**Building Assessment and Evaluation Study  
Of The  
Cranston Area Career & Technical Center  
For The  
Cranston School Department  
December 2011**

**Building Assessment & Evaluation Study**  
**Cranston Area Career Technical Center**  
**For The**  
**Cranston School Department**

## Building Assessment and Evaluation Study Cranston Area Career & Technical Center 100 Metropolitan Ave Cranston RI, 02920

FINAL REPORT: December 20, 2011

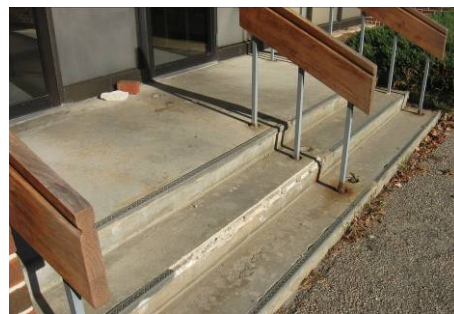
Nosings on concrete stairs are spalled and have come loose. The railings are rusted out at the base and need replacement. The railings do not meet current codes.

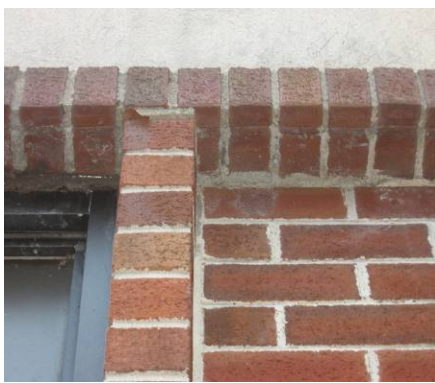
Missing mortar and broken brick.

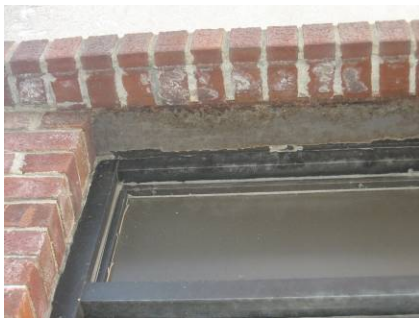
Delaminated steel lintel.

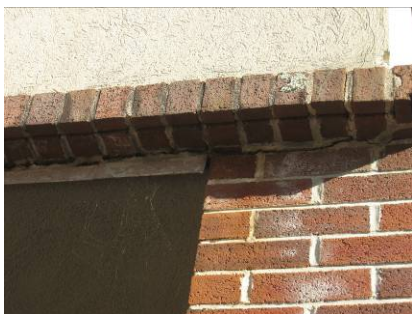
Cracked brick and mortar at accent band of brick

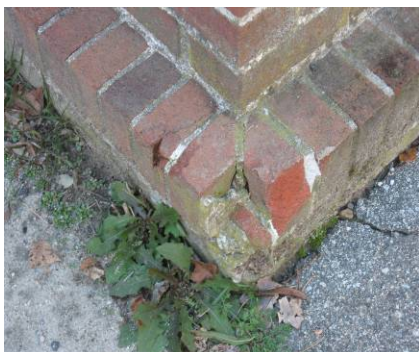
Missing and broken brick at base.

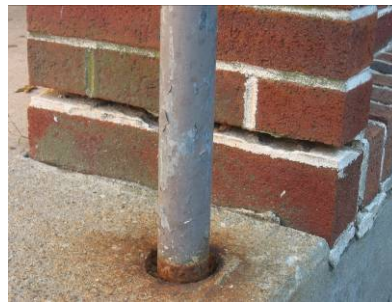
Severe crack in brick joints at ramp area. Rusted railings.

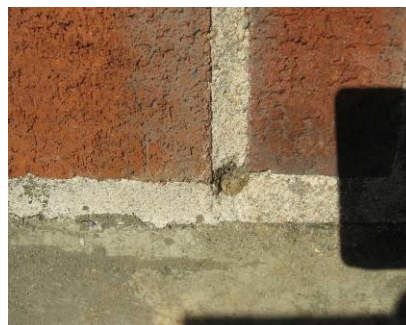
Plugged weep holes.

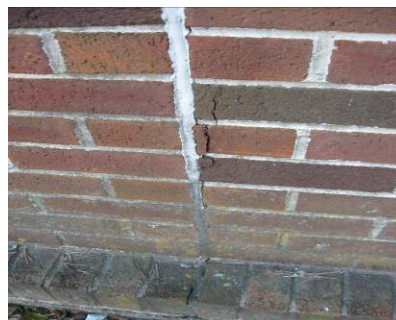
Cracked brick veneer and exp. Joint in poor condition.

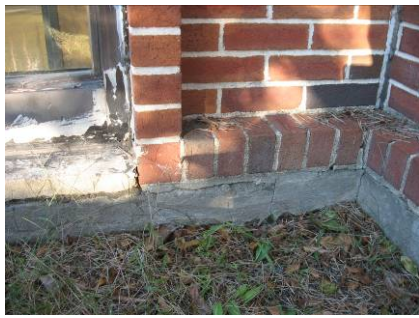
Cracks in foundation around windows.

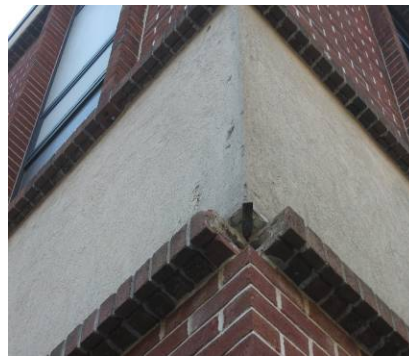
Missing brick at accent banding.

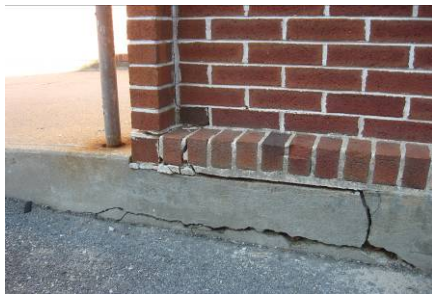
Severe crack in foundation and brick near ramped entry.

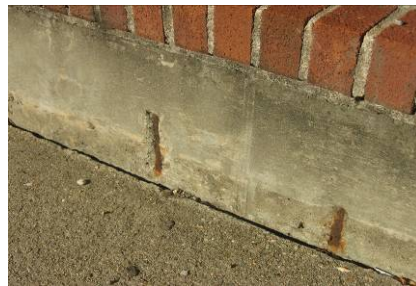
Steel rebar exposed in foundation at ramped entry.

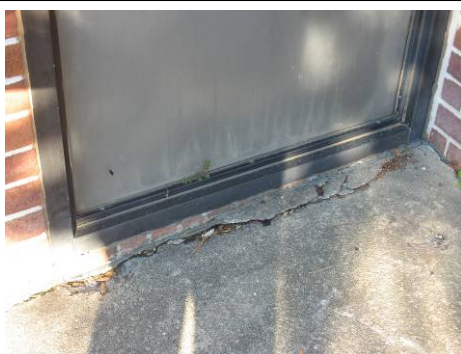
Cracked foundation under window.

There are many areas where the concrete under the windows has cracked and spalled which needs to be repaired to prevent water infiltration.

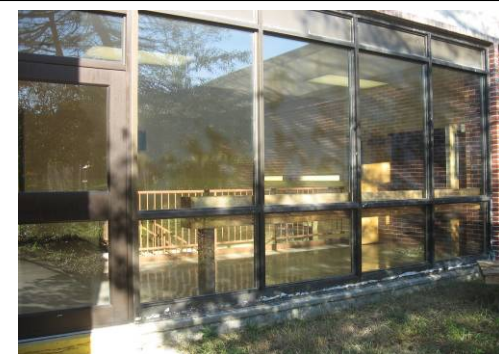
Window wall

The windows on the first floor of the building are full height units that sit on the foundation at floor level. The thermal glazing seals on most of the windows are past their life cycle and leaking resulting in fogged glass. The seal at the base of the windows at the foundation or floor is in poor condition and has failed in most cases resulting in water and moisture entering the building from the exterior. The windows on the upper level and ground level are in the same poor condition. It is recommended that all windows be replaced with new aluminum thermally broken insulated units.

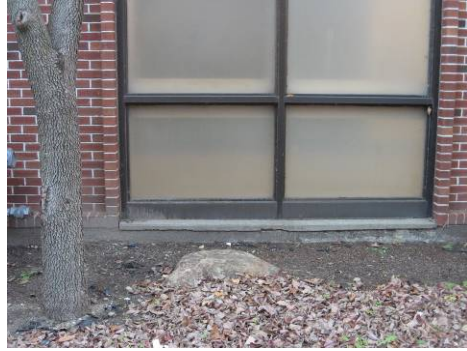
Base of first floor window where The concrete is spalled allowing water to infiltrate the interior.

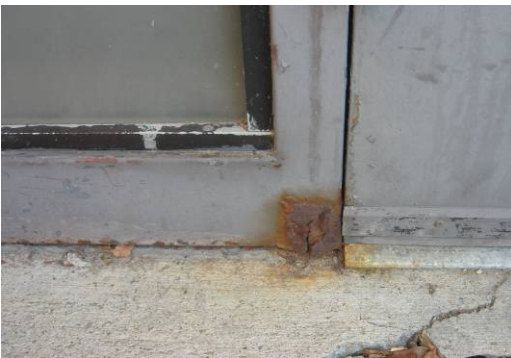
Bottom of exterior door frame rusted.

The exterior doors are rusted out and weather stripping is broken or missing from some doors. It is recommended that most exterior door systems be replaced.

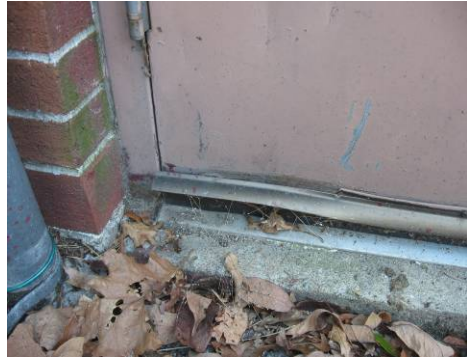
Damaged door and weather stripping.

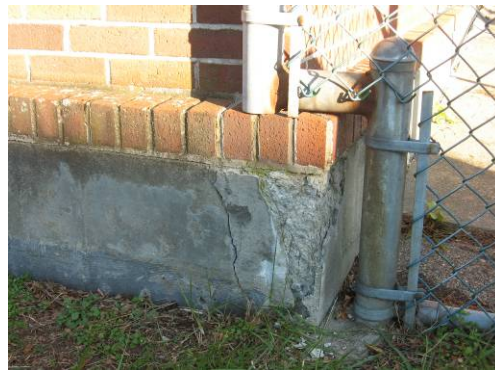
Broken and spalled concrete foundation

1. The concrete slabs around the entrances and exits are cracked and need repair and / or replacement. Some areas of the foundations are cracked, broken and spalled which will need repair.

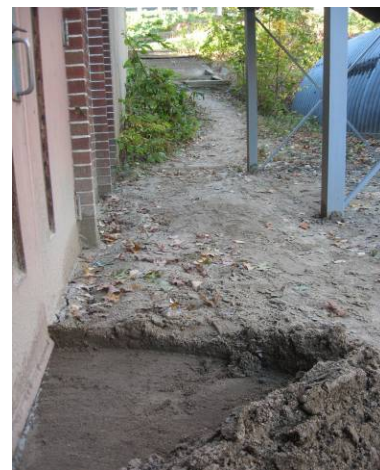
Gravel washed out from upper elevation.

3. The old exterior stair at the rear of the building (NE corner) has been completely washed out and is a hazard at the present time. The stairwell used to be constructed of wood timber tread / riser nosings with gravel infill treads. The wood members have rotted away and the gravel treads have been washed out. There are no railings and there is no evidence that railings ever existed. All the gravel has washed out and down to the lower grade and has blocked one of the exit doors from the construction lab V-11. It is recommended that the entire stair be replaced and new code compliant railings be installed.

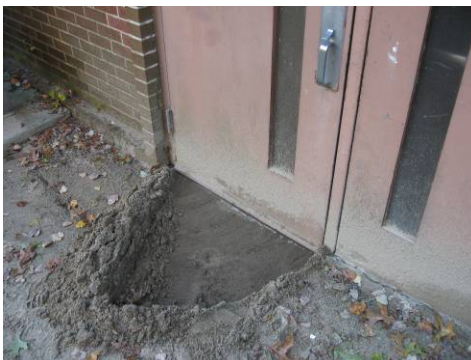
Gravel washed out to grade level and blocking exit door.

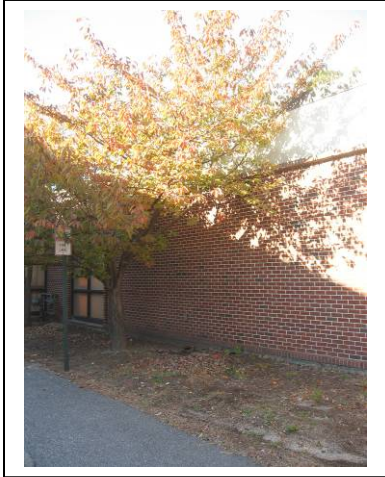
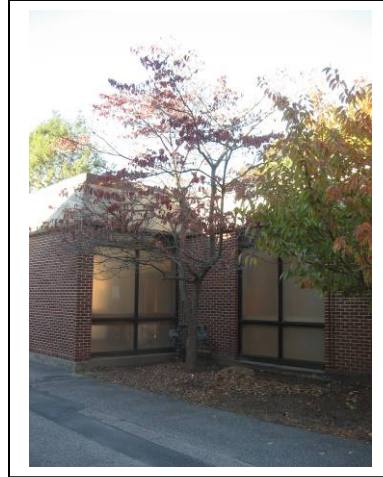
4. There are two memorial dedication trees on the west side of the building that need to be trimmed back from the building.

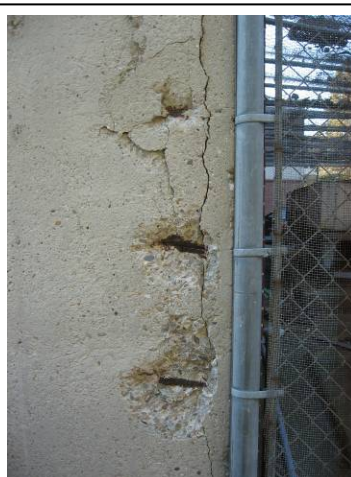
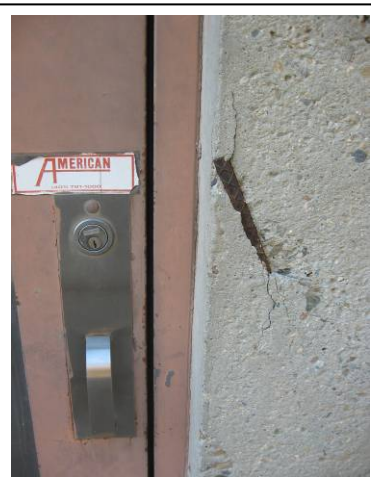
6. The steel rebar is exposed at the S.E. corner of the building outside the mechanical room and at the doorway to the Aquatics Lab.

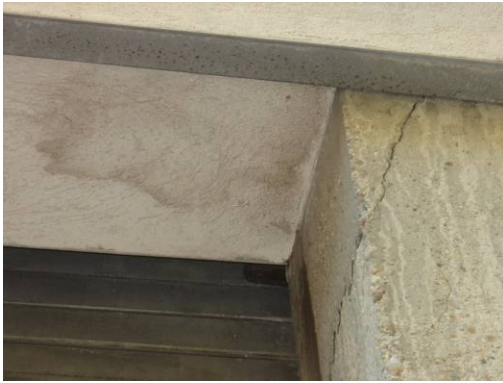
7. The foundation is also cracked at the S.E. corner and is in need of repair. There are various cracks in the concrete columns at the garage door openings that will also need to be repaired.

Crack in concrete column.

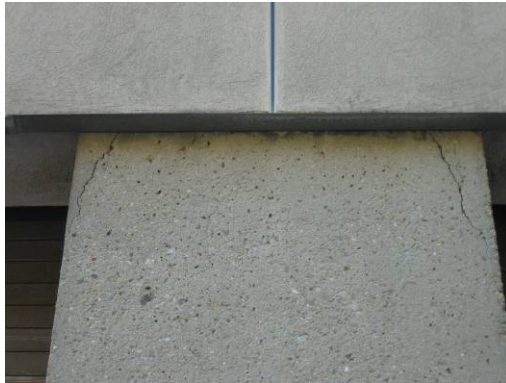
Cracks in concrete column.

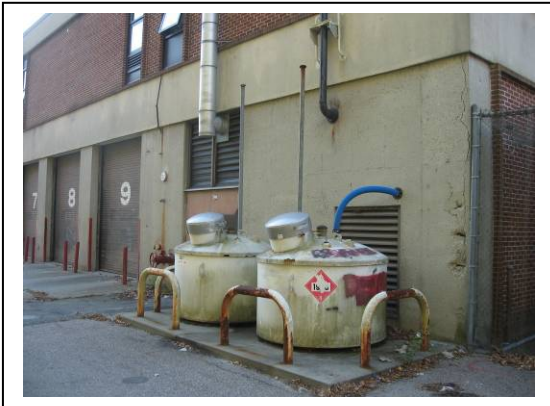
8. The motor oil storage tanks outside the mechanical room previously used for the former automotive shop should be removed.

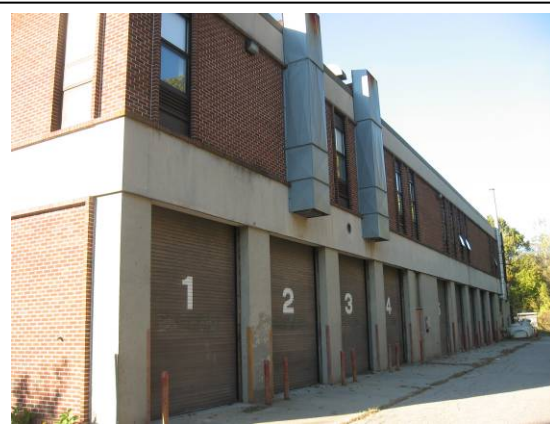
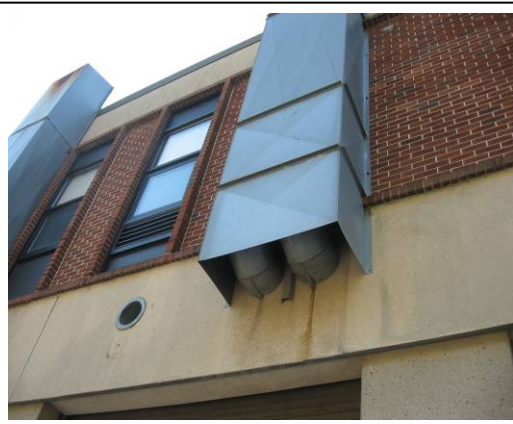
9. Various abandoned ductwork on the south building façade should be removed and anchors removed and holes patched.

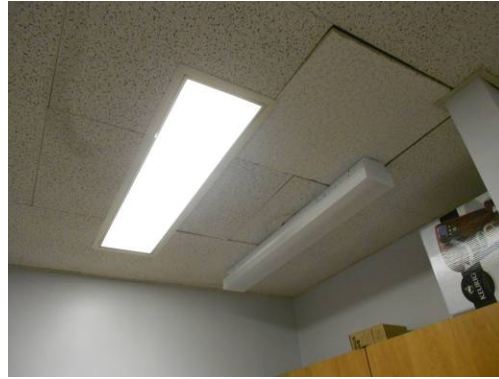
Ceiling tiles in poor condition. Some stained. This is typical throughout.

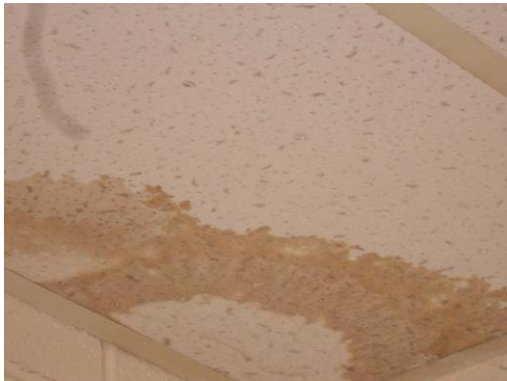
Ceiling tiles stained and sagging. Typical

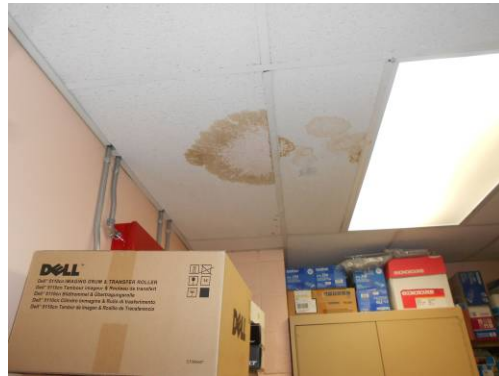
Ceiling tiles stained and sagging. Typical

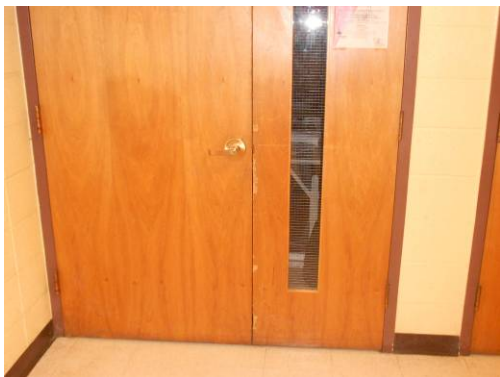
Door and side light chipped and damaged.

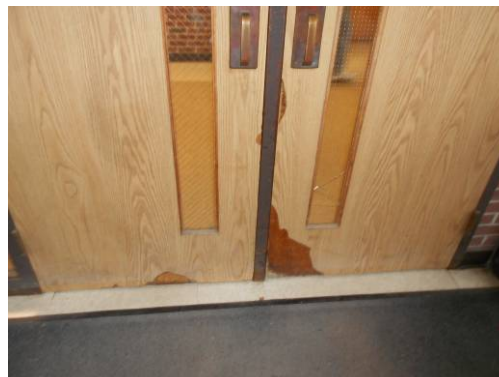
Door damage. Typical throughout building.

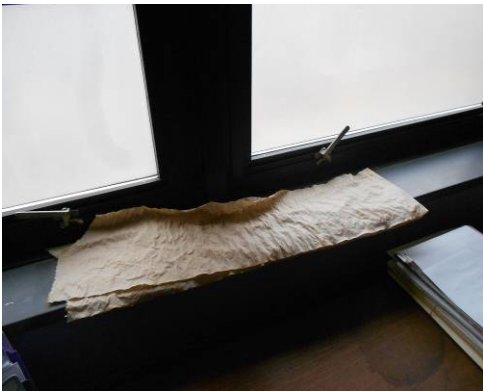
Example of window leaks. Typical.

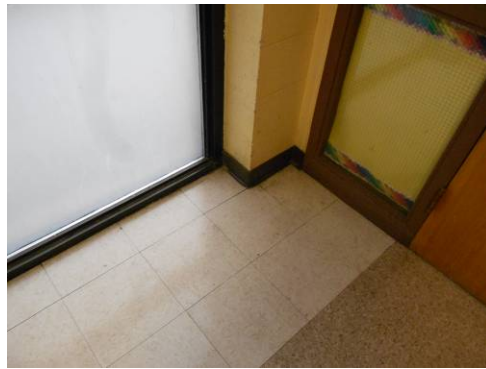
Mismatched floor tiles. Vinyl tiles coming loose. This is typical throughout.

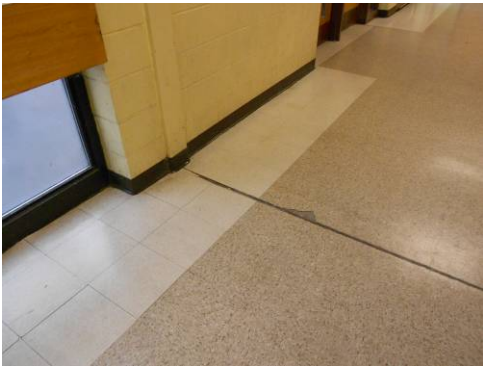
Damaged floor tiles and the expansion Joint needs to be repaired. Typical.

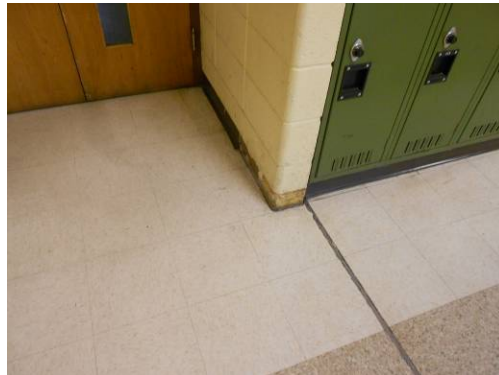
Wall base missing and another example of an expansion joint problem.

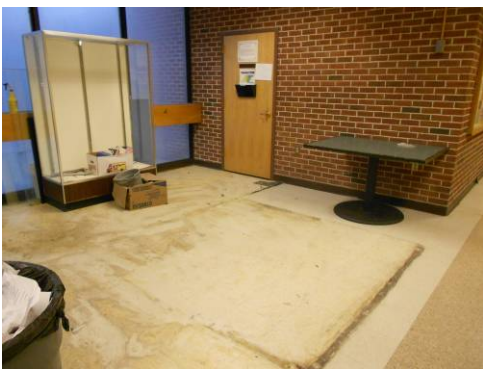
Example of flooring issues that need attention.

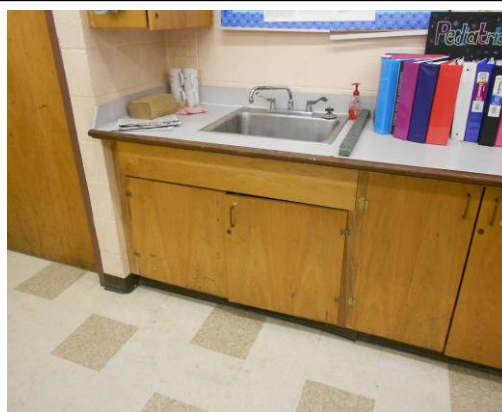
Cabinets do not meet the accessibility code.

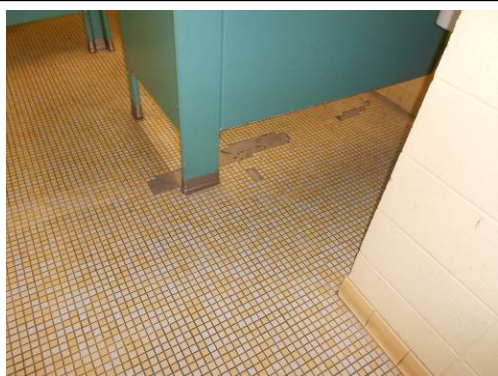
Typical ceramic tile problems in toilet Rooms.

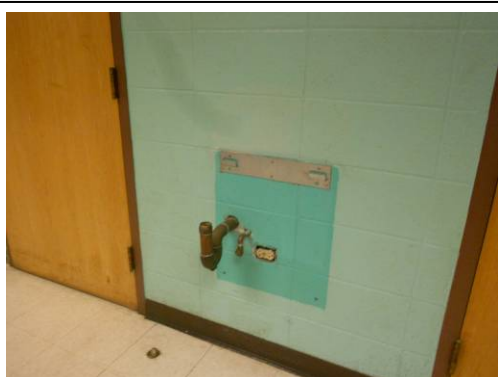
Water fountain removed. This is a code violation.

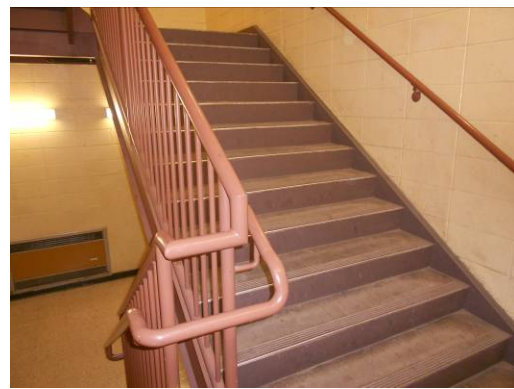
Treads and risers should have non-slip  
Rubber treads and risers installed.

Stairwell treads and risers	There are no rubber treads or risers in the stairwells	Install new rubber treads and risers and landings.	NA	\$15,000
Suspended ACT Ceilings except kitchen areas.	Stained and broken ceiling tiles throughout building. Sagging ceilings due to damage.	Replace all ACT ceilings.	\$15,000	\$90,000
Kitchen lay-in ceiling system.	Dirty / old and broken ceiling tiles.	Replace ceiling system using washable ceiling tiles.	\$4,000	\$10,250
Doors and hardware	Doors are damaged and worn. Hardware is broken and some does not meet code.	Replace doors and hardware.	\$30,000	\$156,000
Toilet rooms	The toilet rooms do not meet the accessibility code. The ceramic tile is coming loose and there are some missing tiles.	Completely renovate the toilet rooms and redesign to meet code. Replace all ceramic tile, fixtures, toilet partitions and accessories.	\$75,000	\$250,000
Misc window jamb and sill repairs.	Repairs necessary at new windows	Provide new sills and paint jambs and heads.	\$5,000	\$10,000

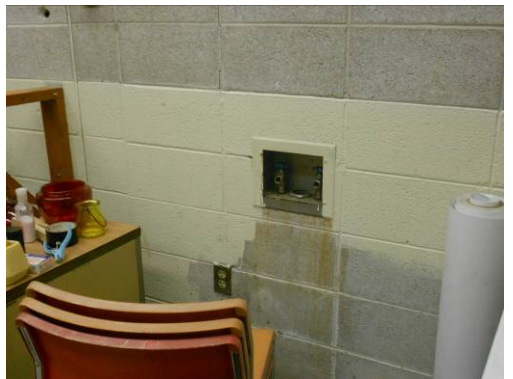
Washing machine connection in wall that Is leaking.

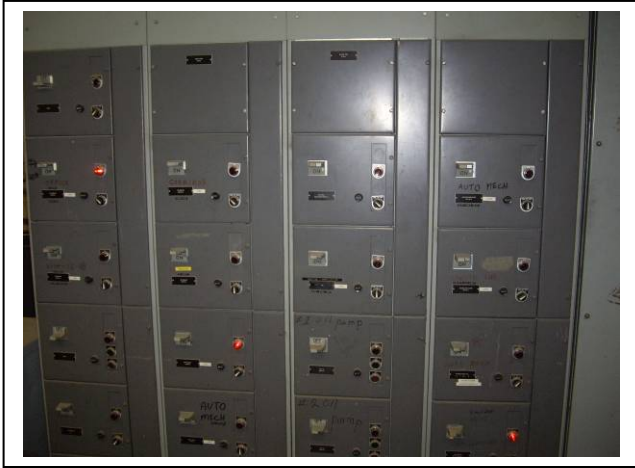
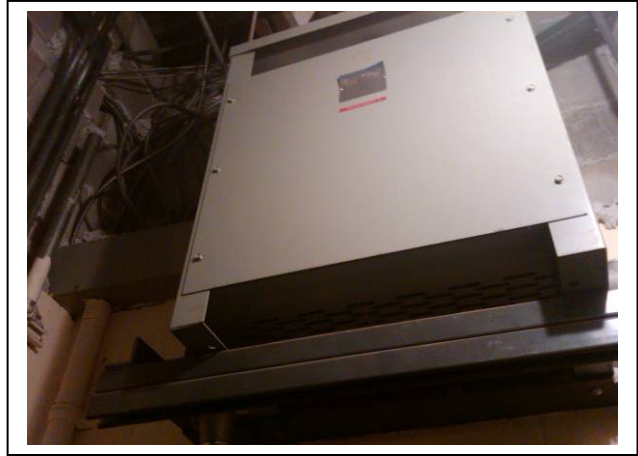
The electrical closets are relatively small and a majority of the dry type transformers are mounted up high supported by I beams. This makes maintenance and replacement of these transformers very difficult when one needs to be replaced.

When a transformer fails, disconnect and abandon it in place and locate a new transformer at a more serviceable location.
